Attachement with e-mail dated 16th March 2018 concerning cracks in the stiffeners ring of type Z23A tank wagons series Zacns, capacity 87m3 ans Z24A, tank wagons series Zacns of 97 m3

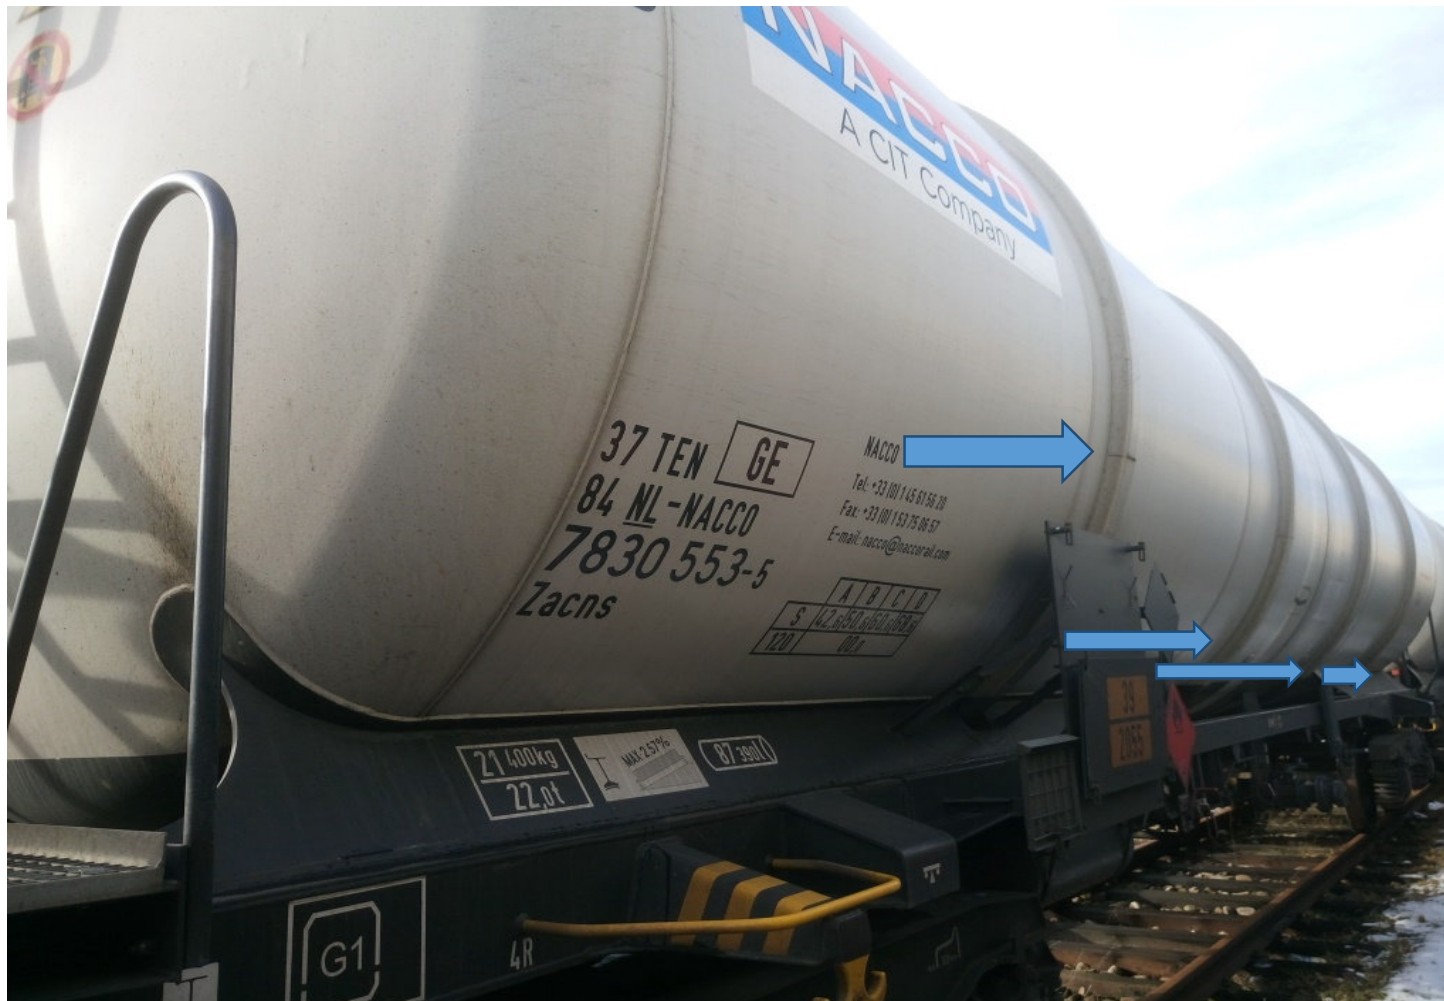
Light blue arrows point at the possible cracks positions

For the exact position of the concerned welds see picture 2: tank 3D model snapshot, where applicable position numbers are given, for welds placed at the stiffening rings)

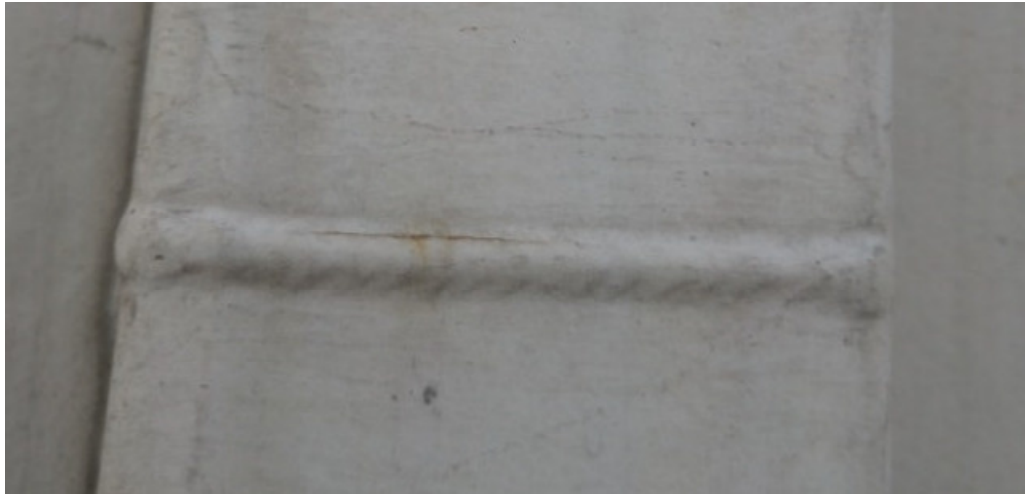
Size of the crack could be small as shown on the picture

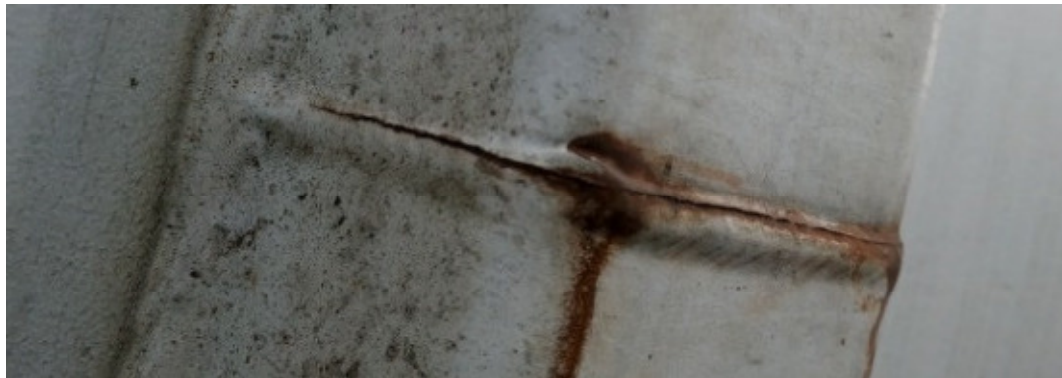
or bigger as shown on the picture
