TRAFIKKVERKET

# Incident on the Bergslagen line

**Preliminary report**

13 September 2019

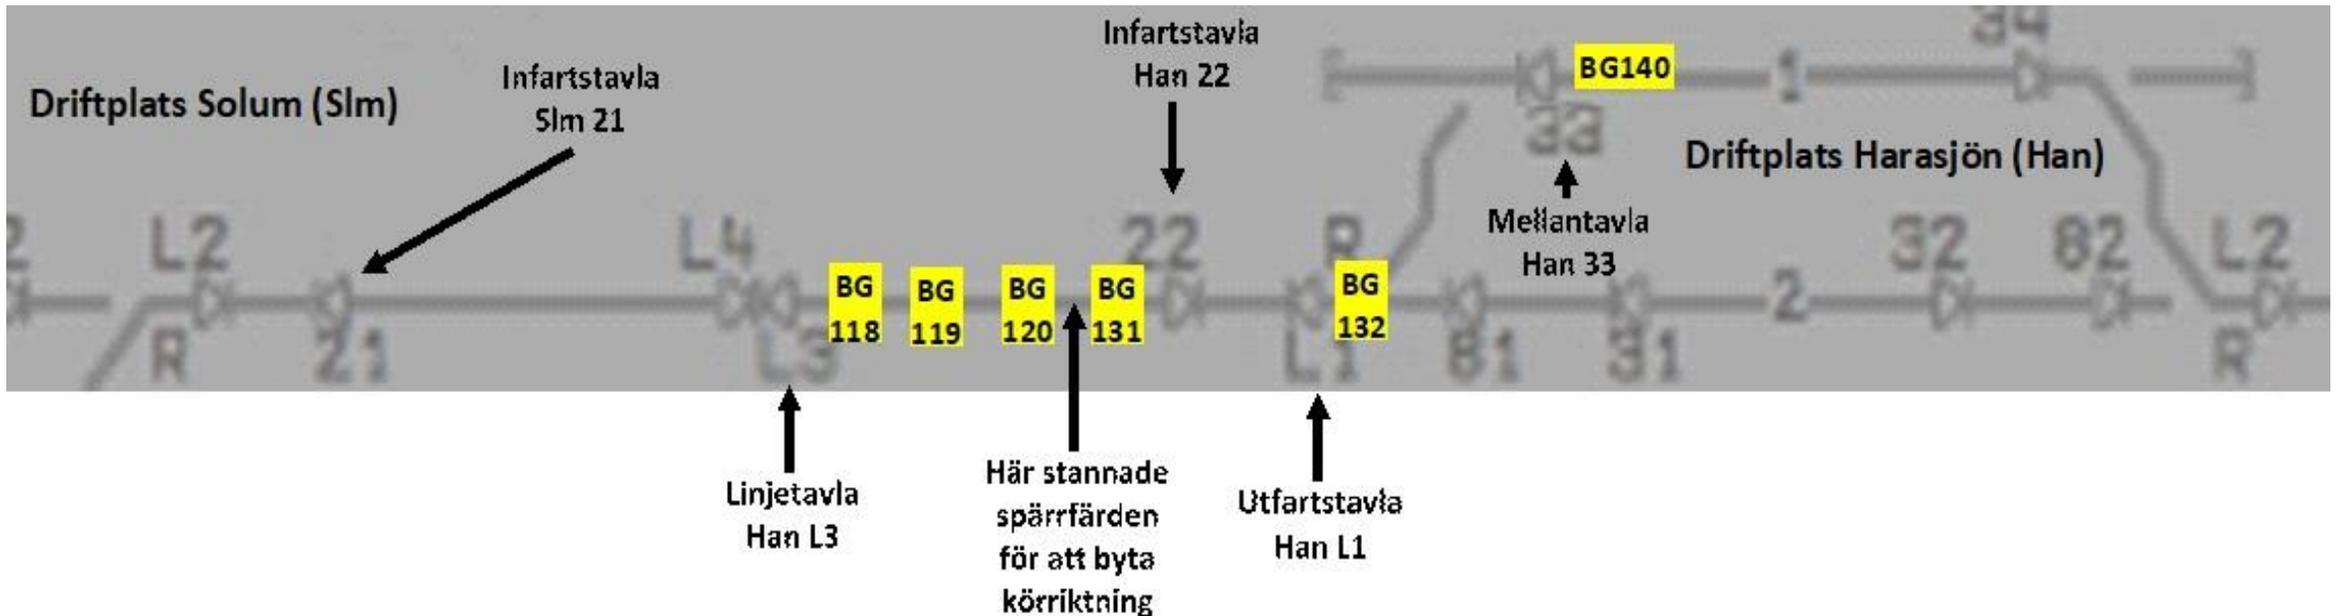
1. The maintenance vehicle started with a movement authority, operating mode "full supervision" (MA-FS) from Harasjön track 1 (intermediate board 33, balise group 140).
2. The vehicle stopped out on the line after having passed balise group 131, but before balise group 120.
3. The driver performed a "End of mission" and the MA was withdrawn.
