# Safety incidents on ETCS Level 2 lines in Switzerland on April 16th and June 27th 2019

File reference: BAV-503.233-2/1/1

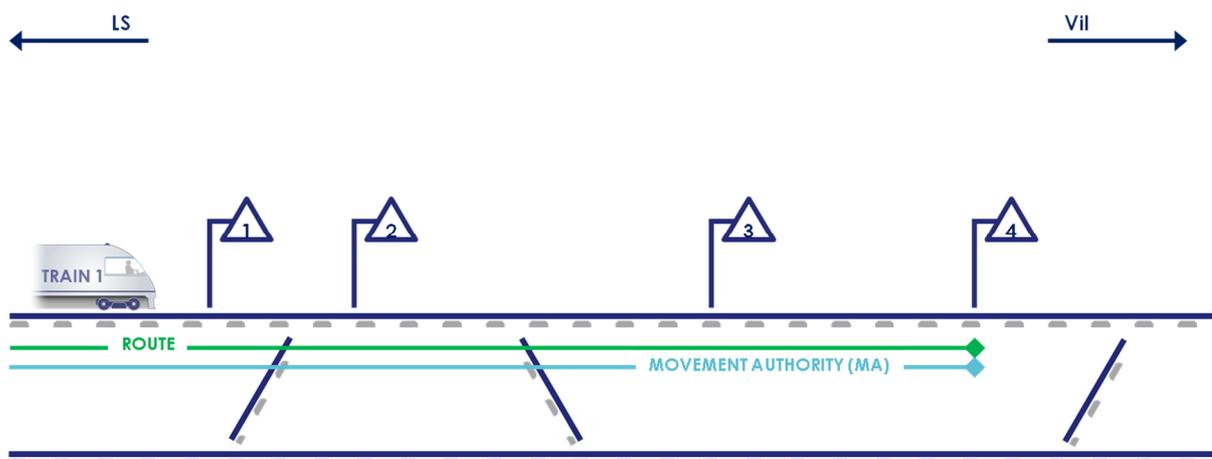
Figure 1

- Train 1 runs from LS to VII. (set route is indicated in green, MA is indicated in blue)
- All signals have release speed (Figure 1)
- Train 1 shows a large confidence interval (indicated in red) (Figure 2)
- Section between Signal 2 and 3 is occupied by train 1, min SFE remains in front of Signal 2 (Figure 2/3)

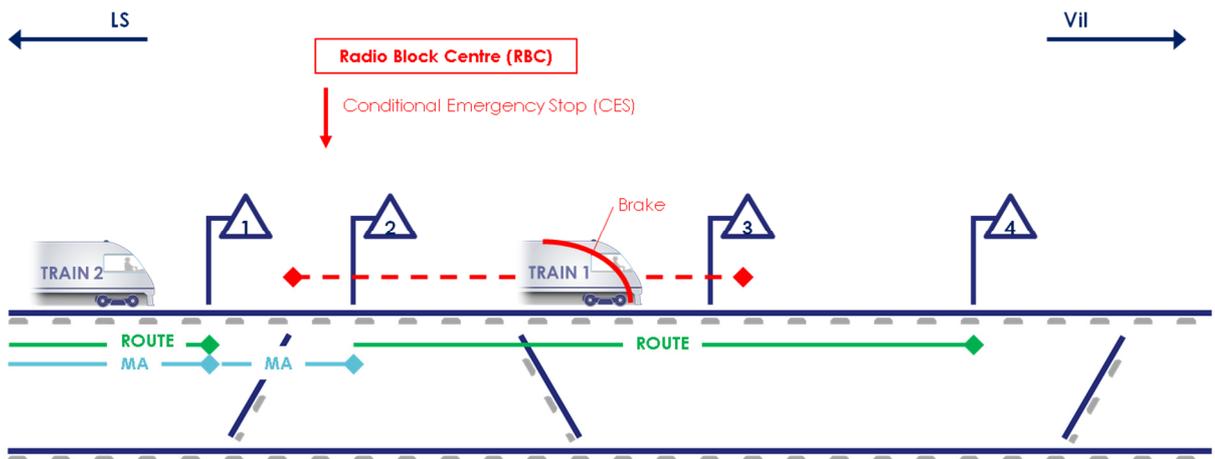
Figure 3

- Due to the function “signal stop evaluation” (1), a new MA of train 1 is sent with EoA at signal 2 (Figure 3)
- Train 1 proceeds (with RS), min SFE remains in front of signal 2. No trip occurs.
- Train 2 approaches signal 1 (Figure 3)
- Route for train 2 is set (to pass by train 1) (Figure 4)
- From RBC point of view train 1 (due to minSFE) is still in front of signal 2 (Figure 4)
- The MA based on the route set for train 2 is assigned to train 1 which leads to a critical situation (Figure 4)
- (1): by passing a signal and the occupation of the section, a CES is sent to the train at a location 75m in advance. If the CES is considered, a new MA with a EoA at this signal is sent to the train (Figure 4)

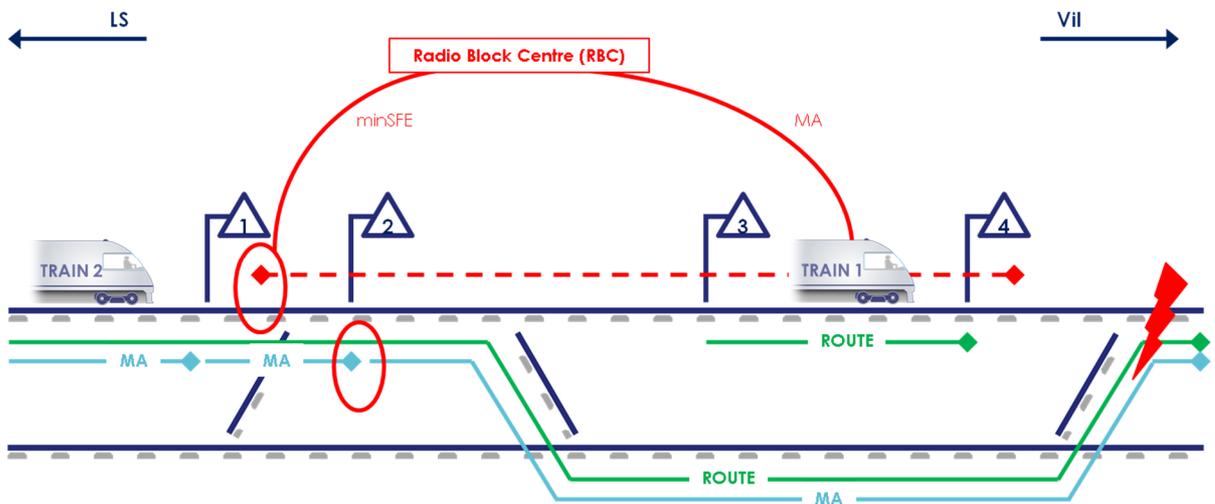
Figure 4

The above described chain lead ultimately to a reaction of the RBC to issue a MA to the train that had gathered a significant inaccuracy in its position.
