URGENT SAFETY ADVICE

RAIB USA No.		ISSUE DATE:	
TITLE	Maintenance arrangements for wagons that primarily carry dangerous goods.		
SAFETY ISSUE:	Suitable processes, facilities, tools and equipment may not be in place to prevent safety critical system components becoming unsafe due to insecure fastenings.		
SAFETY ADVICE:	<p>Entities in Charge of Maintenance (ECMs) should review their system of inspection and maintenance for wagons that primarily carry dangerous goods, to ensure that they have appropriate arrangements in place to manage the safety risk associated with malfunction of the braking system. This should include an assessment of the adequacy of:</p> <ul style="list-style-type: none">• facilities, tools and equipment at all maintenance locations;• systems for assuring the competence of those involved;• management systems and instructions for assuring the quality of work undertaken;• methods for initial and ongoing assurance of the security of fastenings; and• processes for the identification and tracking of safety critical components. <p>This assessment should take into account the particular hazards associated with conveying dangerous goods.</p>

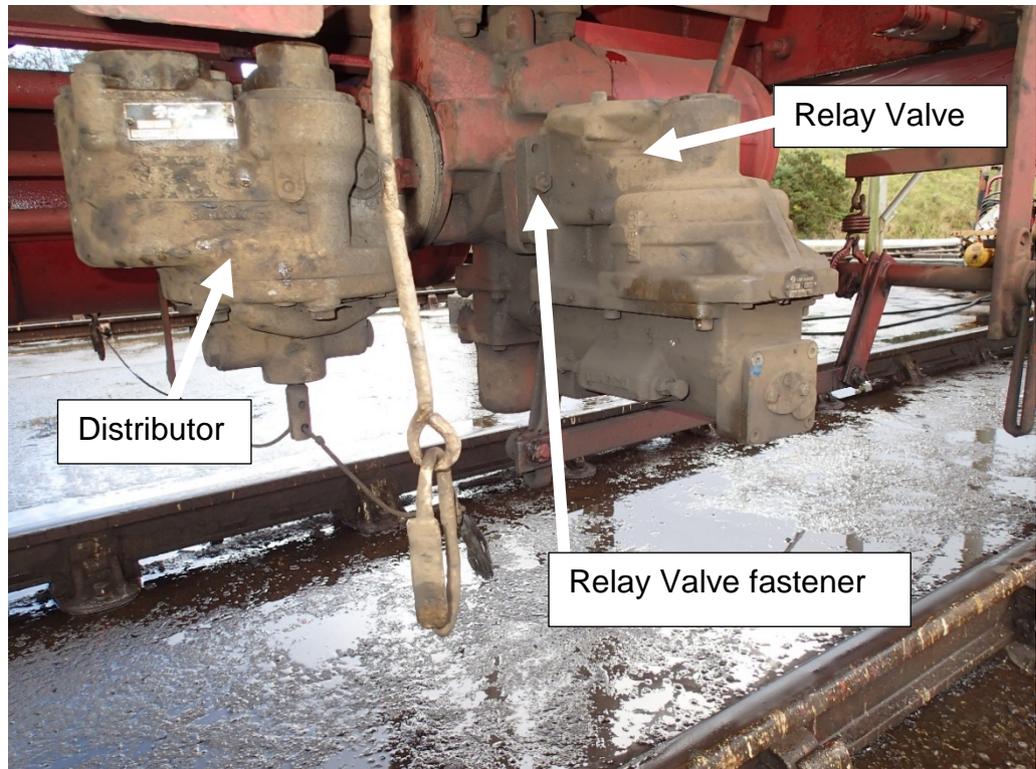
Examination of the brake group on the third wagon (TEA wagon GERS89005) found that the relay valve was loose on the pipe bracket. A sealing ring from one of the

ports in the mating face had migrated to a position where it lodged between two other ports, distorted the sealing rings of those ports, and probably created a route for air to pass directly from the auxiliary reservoir to the wagon brake cylinder. This would have had the effect of applying the brakes on the wagon, producing the result described above.

Brake group on TEA wagon

The ECM for the wagon was unable to identify with any degree of certainty where and when the fastenings of the relay valve had last been disturbed. However, this may have taken place during routine repairs in the sidings at Robeston terminal or during scheduled maintenance elsewhere. There was no record of any check on the tightness of the fastenings ever having been made, and no process requiring such checks or provision of any measures, such as witness markings, which would have indicated that fastenings were becoming loose.
