Proposed actions on the problem of cracks emerging on Sggmrss 90´and Sggrss 80´ wagons

Report No: ZP 01/2024-Nb

Made on: 19. 7. 2024

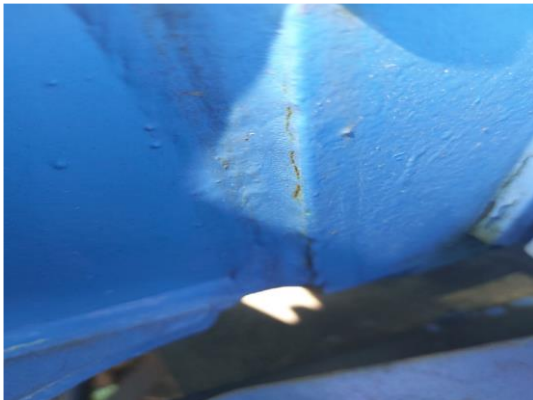
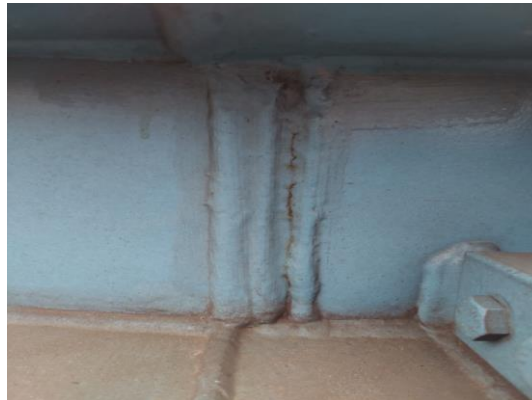
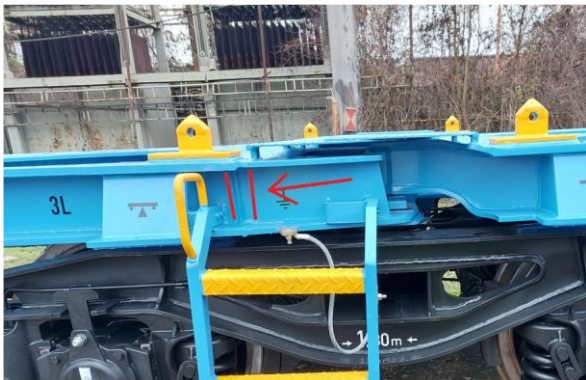
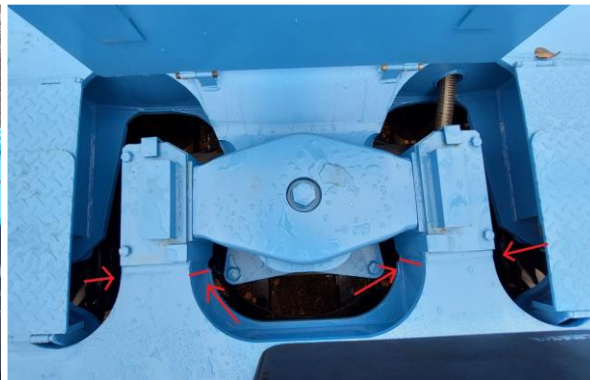
On several wagons of the Sggmrss 90' and Sggrss 80' series, manufactured by Nymwag CS a.s. with production dates from December 2021 to August 2023, defects that could potentially lead to cracks were found in the welding of the underframe.

As seen in the attached photos, there were defective welds present in the joint area. The defective welds were repaired during normal operation of the wagons during routine maintenance inspections.

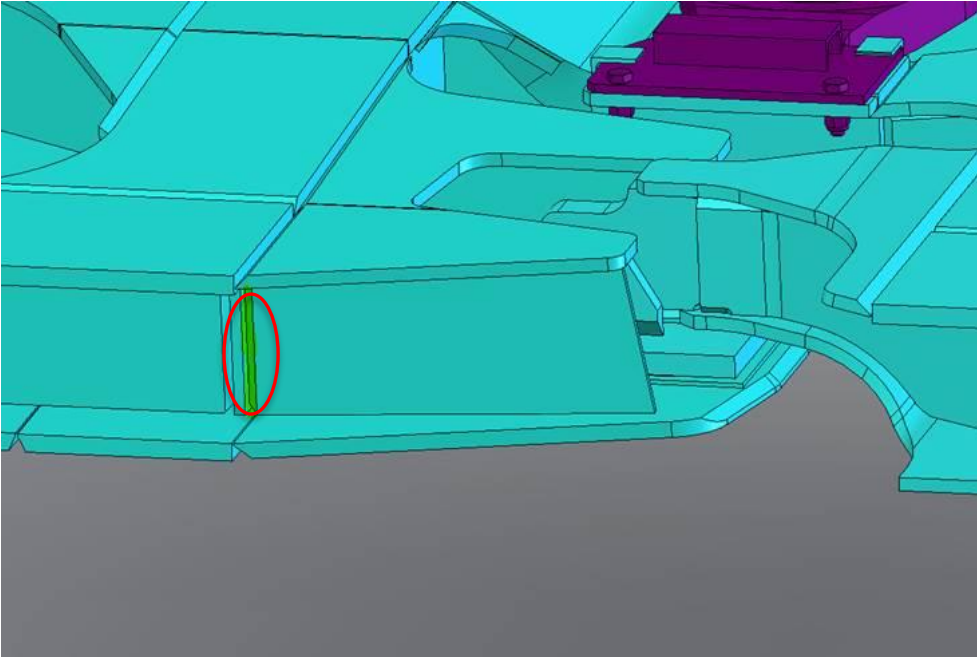
Area A, vertical weld of the wagon part A side bearer:

Weld cracks were discovered in the area of the articulation on the container articulated wagons of the Sggmrss 90' and Sggrss 80' series.

Based on the analysis carried out by the manufacturer, it can be concluded that the cause of the cracks is non-compliance with the production technology in some wagons.

Cracks in welds are not permitted. A crack in the welds mentioned will not cause direct destruction of the structure. We recommend to put the wagons with cracks out of service and repair the welds.

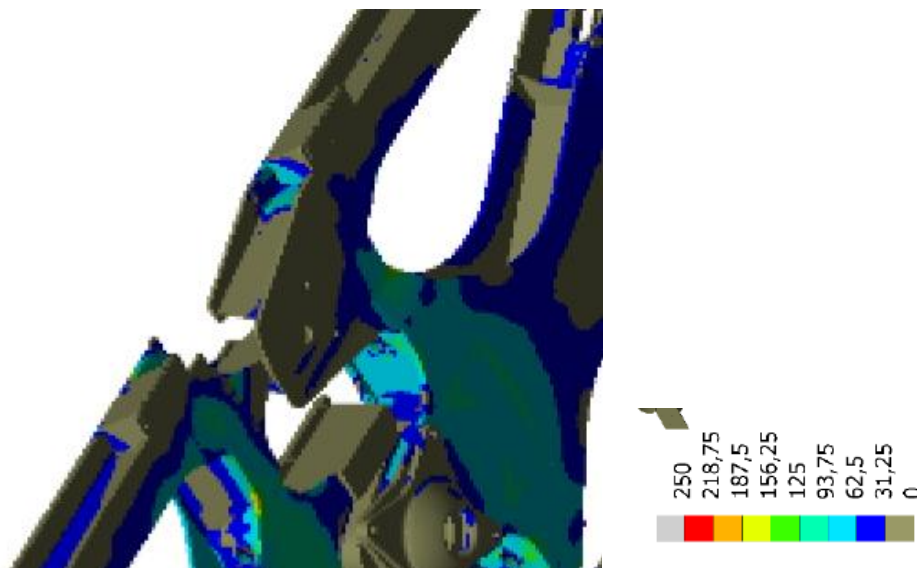
According to the calculation report, the weld was analysed neither for fatigue (coordinates $x=10060\text{mm}$, $y=1023\text{mm}$, $z=1092\text{mm}$) nor for exceptional loads.

According to Figure 148 of the report, the maximum equivalent stress in the wider area around the weld according to von-Mises is up to 125 MPa under fatigue loading condition U-03 (vertical load 1.3g + transverse load 0.2g).

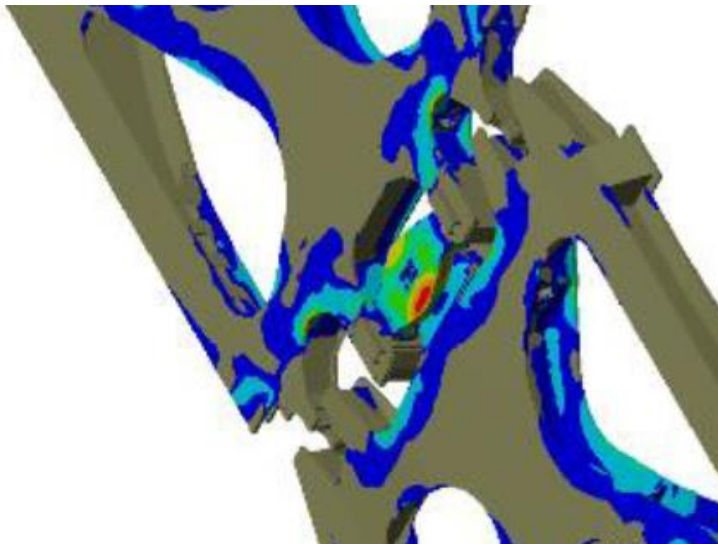
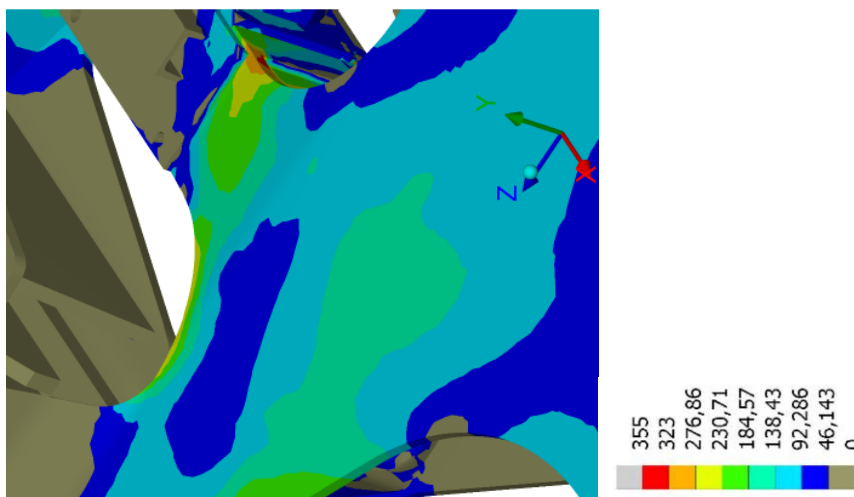
According to the report, the weld was not analysed for fatigue (coordinates x=10600mm, y=1015mm) or exceptional loads.

According to Figures 103 and 81 of the report, the maximum equivalent stress in the wider area around the weld according to von-Mises is up to 185 MPa under the exceptional loading conditions V-12 (combination of 1500 kN stress and vertical load on the loaded wagon) and V-10 (combination of 1200 kN pressure on bumpers and vertical load on the loaded wagon).

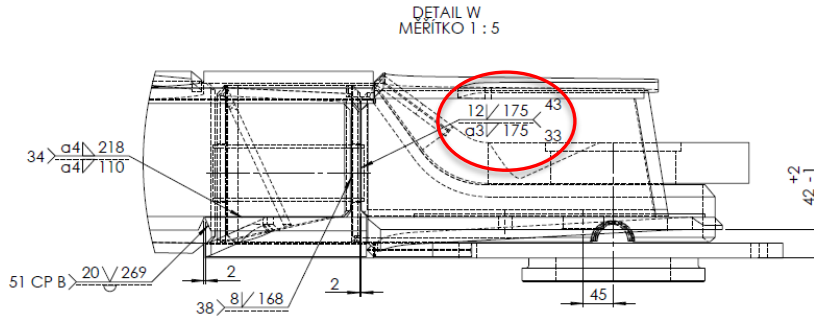
According to drawing No. S009-01-010000

According to EN 15085-3 this is a 10d type weld.

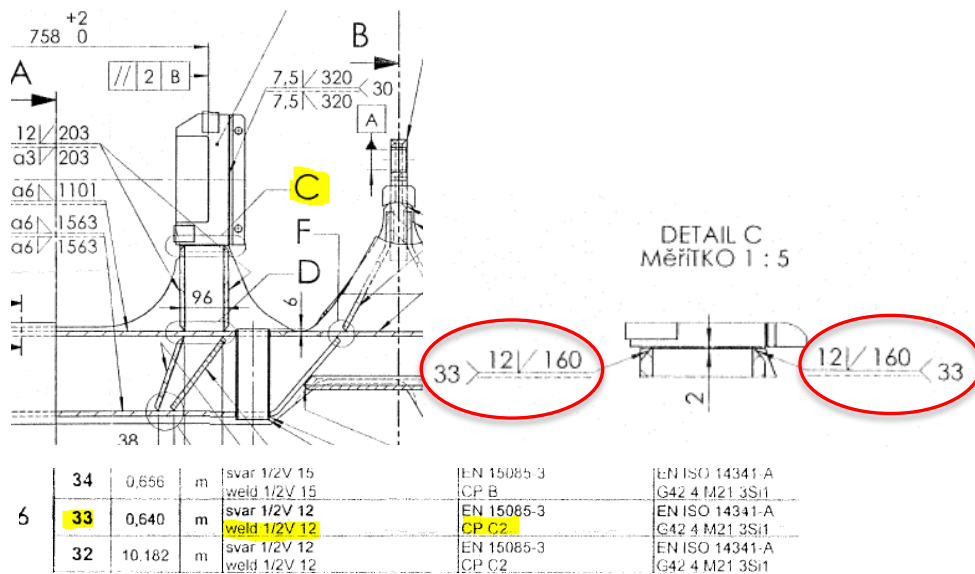
According to drawing No. 206221040.1.2.22

According to EN 15085-3 this is a 10a type weld.

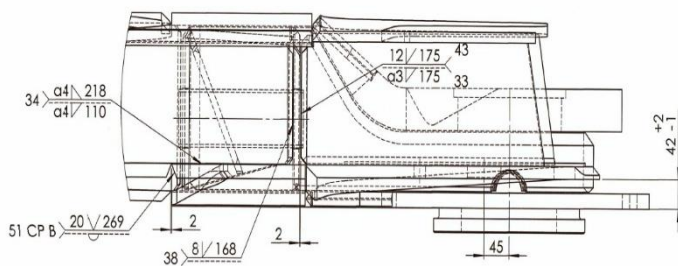
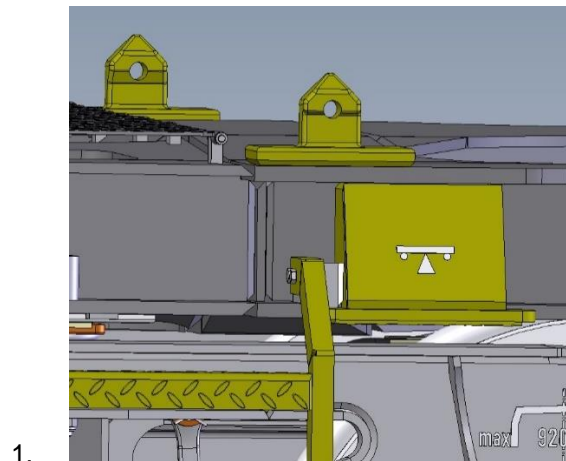
Defects have been detected on the container wagon of the Sggmrss 90 and Sggrss 80' series, on the wagon underframe A, in welds 12HV (pos.43) and 8HV (pos.38). The welds are according to the drawing in CP C2 according to EN 15085-3 (grade C according to ČSN EN ISO 5817).

It is recommended to take the wagons with weld defects out of service and repair them according to the procedure (see Annex 1, Annex 2). Wagons after repair and proper inspection do not need to undergo further extraordinary testing..

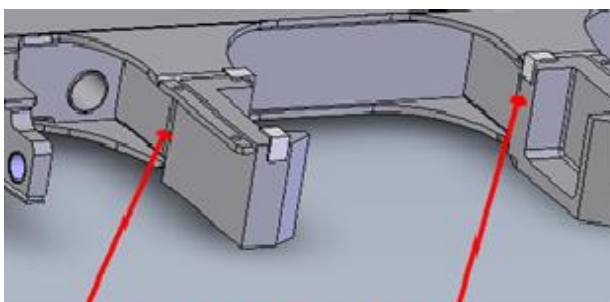
WELD – pos. 33

The container wagon of the Sggmrss 90' and Sggrss 80' series, part B underframe at the weld pos.33 (12HV) - indications of a suspected longitudinal crack-type defect were detected by visual inspection (defect 101 according to ČSN EN ISO 6520-1).

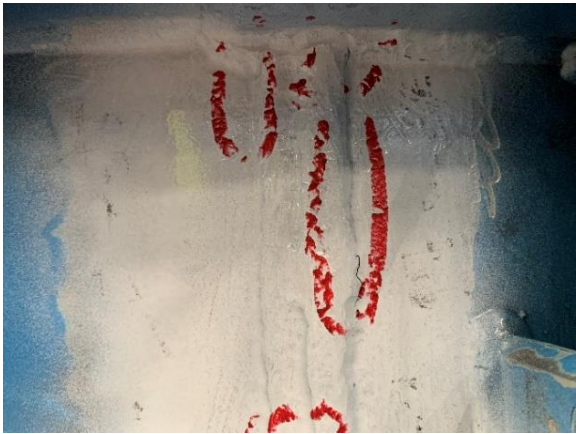
Example No.1

NDT testing of the problem section was carried out using the MT testing on the claimed wagons. The test revealed various defects in terms of the classification of the type of defect within the meaning of the ČSN EN ISO 6520 standard. If defects occur, a corrective action is taken (see Annex 1, Annex 2).

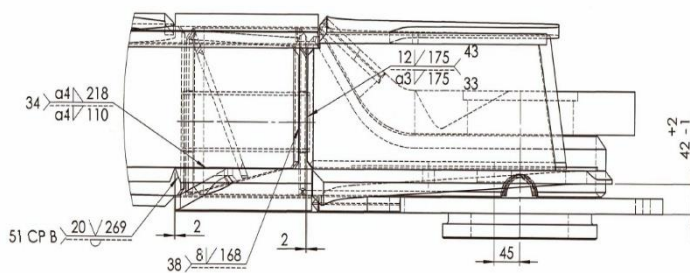
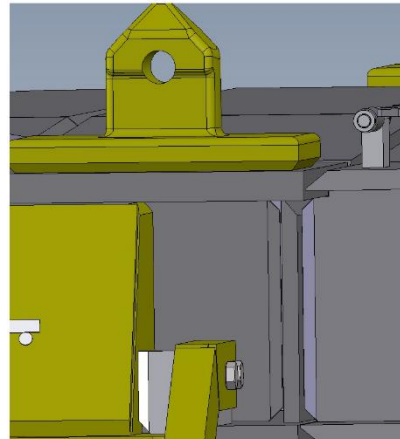
Assembly: Underframe A, drawing No. S005-01-01000, defects in welds 12HV (pos. 43) and 8HV (pos. 38)

Long defect of the crack type, cold joint or if the defect removal continued through the entire thickness of the material

Remove paint at the welds to be inspected with a wire wheel and brush, mark and document any defects (report + photo).

1) Use an electric hand grinder and a technical hand cutter to remove the original weld in the place of the defect. Check by using MT testing. If the defect persists, continue in the same manner for a greater length until the defect is completely removed. Prepare the weld surfaces, cut the root gap with a cutting grindstone (should be 2-3 mm if possible).

2) Weld a new weld according to WPS NWN-026

3) Carry out VT and MT testing after the welding job (quality of the welds according to EN ISO 5817: C). Document that the tests have been made.

4) Renew the paint.

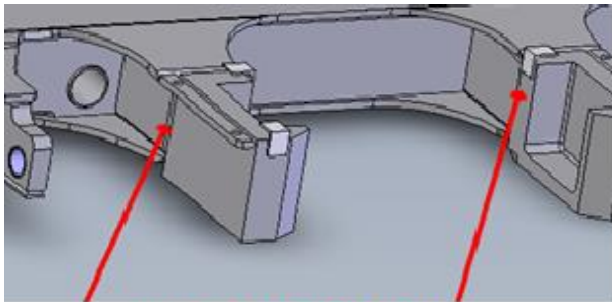
WELD pos. 33

Description of the problem: Indications of a suspected longitudinal crack were discovered by a visual inspection on this assembly, weld with pos. 33 (12HV) (defect 101 according to ČSN EN ISO 6520-1).

Disassemble the articulation assembly. Clean it of any dust and lubricant residue. Use a wire brush to remove paint from the welds to be inspected. Perform an MT testing of the problem area. Mark and document any defects (report + photo).

- If more than one spot on the assembly is being repaired, alternate welding locations to eliminate deformation.
- 1) Weld an auxiliary brace (reinforcement) to the face of the bearings to fix the position of the bearings during repair, which will be removed after the repair is complete.
Welding method No. 135, additional material: EN ISO 14341-A: G3Si1, D 1.2 mm (OK12.50 ESAB). Additional welds FW a3 according to WPS NWK099.

- 2) Use an electric hand grinder and a technical hand cutter to remove the problem part of the weld with the defect. Check for complete removal of the defect using MT testing. If the defect persists, continue in the same manner to a greater depth until the defect is completely removed or the entire original weld is removed. Prepare the weld surfaces for a weld with angles for ½ V groves between approx. 50° to 60° to facilitate welding; when removing the whole weld, cut the root gap with a cutting grindstone (should be 2-3 mm if possible).

- 3) Weld the new weld according to WPS NWN-028

- 4) Carry out VT and MT testing after the welding job (quality of welds according to EN ISO 5817: C). Document that the tests have been made (report + photo)
- 5) Grind off the auxiliary brace (reinforcement), grind off any remains of the auxiliary welds. Renew the paint.
